Model: ESI 1350

Product Bulletin # TDS-191

## Blower Motor Securement Upgrade

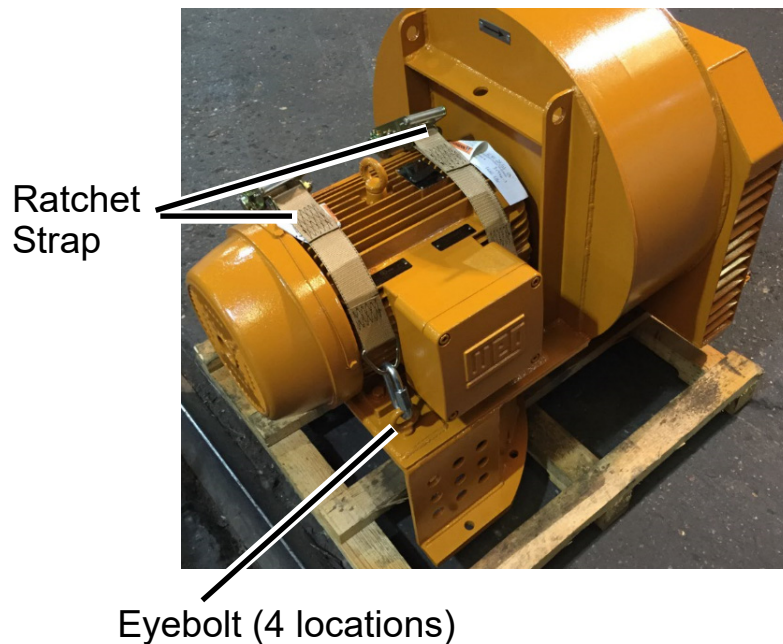
Excessive vibration may loosen the top drive blower on legacy TESCO 500-ESI-1350 top drives, and a lack of periodic inspection may lead to a potentially dangerous dropped-object situation.

Figure 1: Blower Motor Assembly (P/N: 5021368) with improved housing for additional blower motor securement (P/N: 5021370)

An upgraded blower motor assembly (P/N : 5021368) is now available with an improved housing (P/N: 5021370), improving the mounting design for the blower motor. This improved housing has a controlled-machined surface, eliminates the rubber pad, and adds eyebolts and ratchet straps for additional securement. This improvement will be included in new top drive builds. Upgrades to existing top drives may only be performed by the original manufacturer (OEM). Contact Rigline 24/7™ Support to schedule an upgrade to the blower motor assembly.
